Manhole Inspection Summary

Manhole # S65U__004MH

Insp Date: **5/2/08 1:10 PM**

Location Address: **6100 Holabird Ave.**

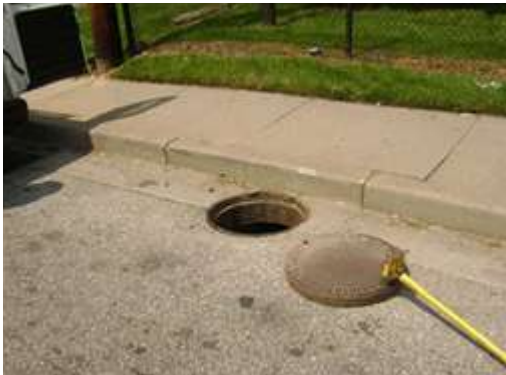
Location View

Comments **SHEETING DUE TO HALF OF THE MANHOLE COVER BEING IN THE GUTTER.**

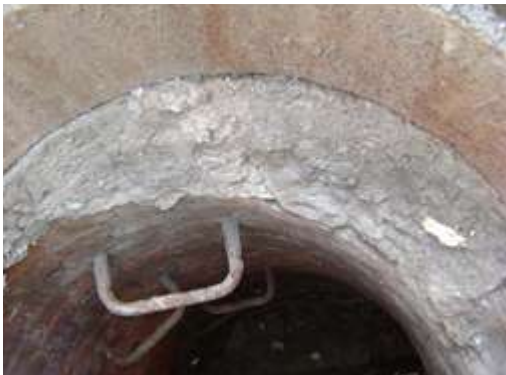
Defect 1

Frame Offset: **6** (in.) Condition: ☐ Sound ☒ **Cracked** ☐ Leaks

frame offset

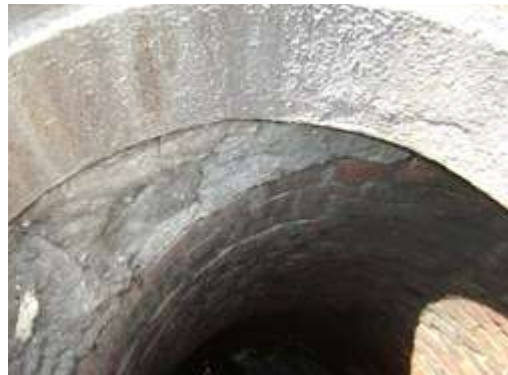
Defect 3

Infiltration: ☐ None ☒ **Joint** ☐ Cracks ☒ **Mortar** ☐ Roots ☐ Wall

cracks in mortar at frame adjustment

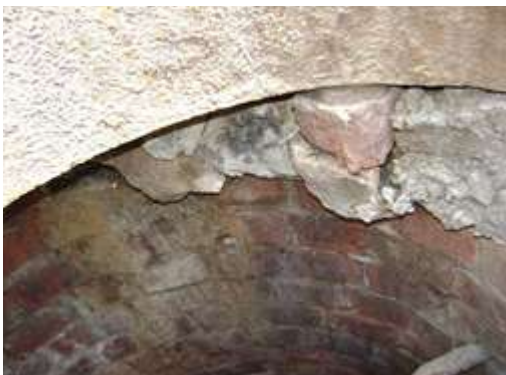
Defect 2

Condition: ☐ Sound ☐ Cracked ☐ Root Intrusion ☒ **Loose Brick** ☒ **Deteriorated**

Loose bricks at frame adjustment

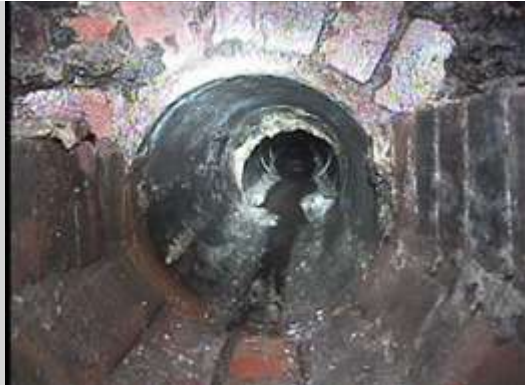
12 O'Clock Outflow

10 in. Circular Gravity Sewer
Pipe Out @ 12 O'Clock

Pipe Height: **9.6** (in.) Rod and Bar (Angled)
Pipe Material: **Clay** ☐ Pipe Lined
Invert Depth: **9.83** (ft.) Flow Characteristics: **Slow**
Deposits: ☒ None ☐ Mud ☐ Sludge ☐ Debris ☐ Grease
Silt Depth: (in.) Deposits Extent:
Infiltration: **None** Pipe Seal Cond: **Sound**

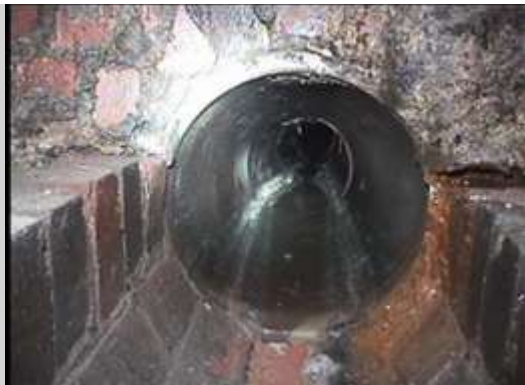
6 O'Clock Inflow

10 in. Circular Gravity Sewer
Pipe In @ 6 O'Clock

Pipe Height: **9.6** (in.) Rod and Bar (Angled)
Pipe Material: **Clay** ☐ Pipe Lined
Invert Depth: **9.42** (ft.) Flow Characteristics: **Slow**
Deposits: ☒ None ☐ Mud ☐ Sludge ☐ Debris ☐ Grease
Silt Depth: (in.) Deposits Extent:
Infiltration: **None** Pipe Seal Cond: **Sound**
